# 2006 Fish Survey in Recently Dewatered Western Irrigation District Canals

**Western Irrigation District**  
Strathmore, Alberta  
T1P 1C1

**Aquality Environmental Consulting Ltd.**  
11216 23B Avenue NW  
Edmonton, Alberta  
T6J 4Z6

**December 2006**

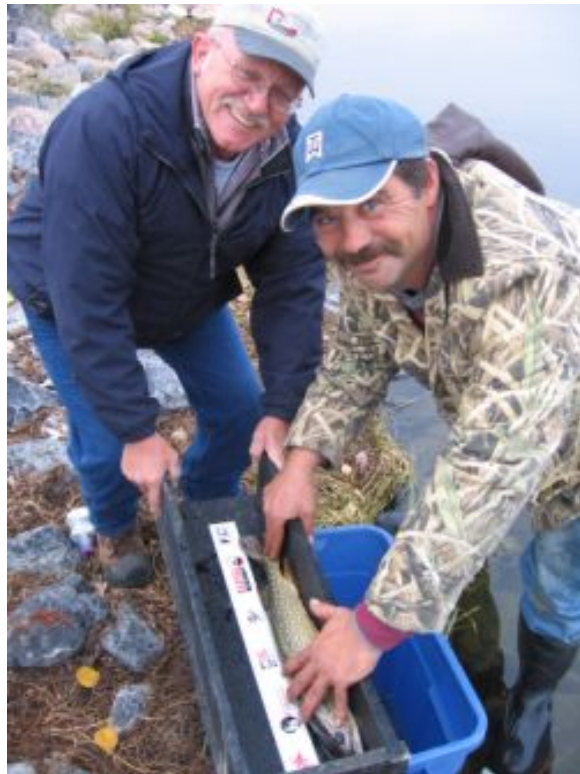
**Figure 3:** Western Irrigation District staff (Dwight Gittel, left and Wes Sproule) measuring captured fish prior to live-release into Chestermere Lake.

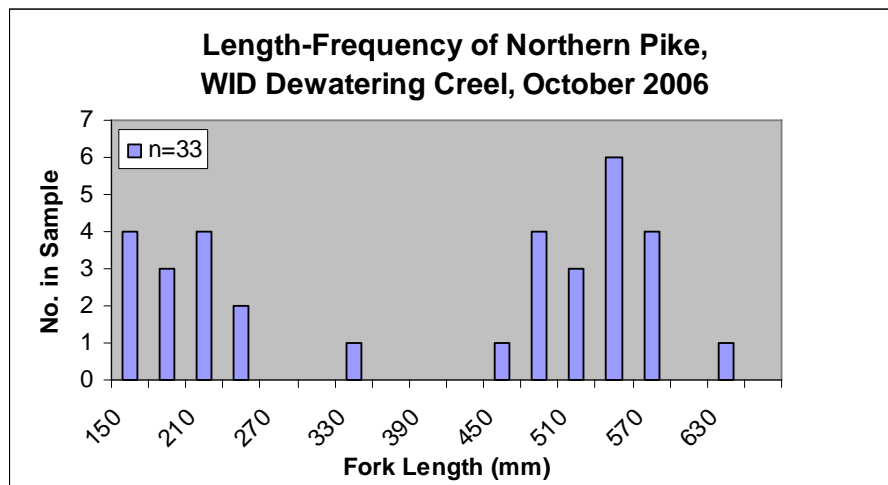
**Figure 4:** Length-Frequency Histogram of Northern Pike captured in 2006 at all sites.

Length-frequency histograms of Northern Pike and Lake Whitefish appear to show bimodal size-class population distribution, although sample sizes are relatively small (Figures 4 and 6). There appears to be a normally distributed juvenile population of Northern Pike (i.e. fish < 340 mm) as well as a distinct normally distributed mature population (i.e. fish > 450 mm). Further study of the fish populations within the canal and their age-class distribution is required to gain a better understanding of how old or large fish are when they enter the canal and how long they remain entrained within the canal system.

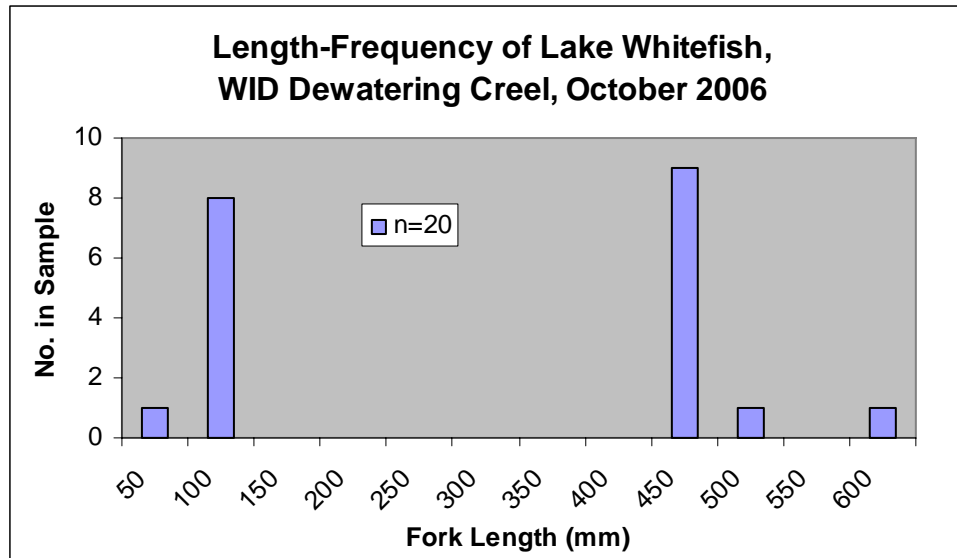
**Figure 6:** Length-Frequency Histogram of Lake Whitefish captured in 2006 at all sites.
