2005 Fish Survey in Recently Dewatered Western Irrigation District Canals

Western Irrigation District
Strathmore, Alberta
T1P 1C1

Aquality Environmental Consulting Ltd.
11216 23B Avenue NW
Edmonton, Alberta
T6J 4Z6

November 2005

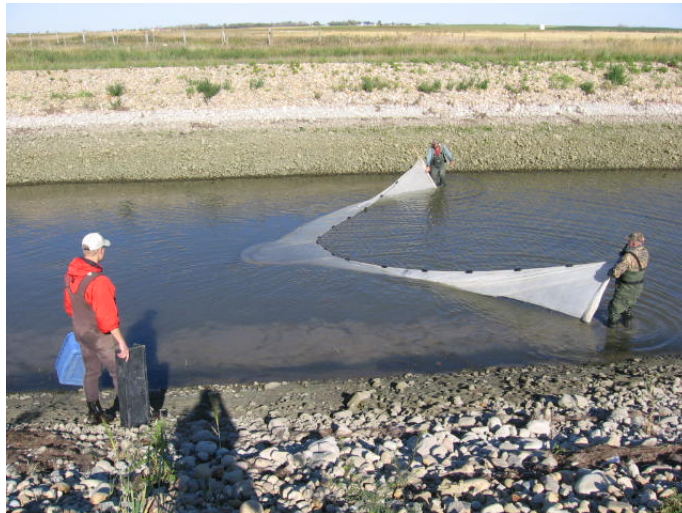
Figure 3: Seining in a easterly direction along Canal A immediately upstream of the new measuring flume. Wes Sproule (centre) and Dwight Gittel (right) use a seine net in the shallow waters of Canal A while Jay White observes.

Site 4a: A new site in 2005. A measuring flume in canal A located between Site 1 and Site 4 was constructed in the winter of 2004-2005. The upstream side of the flume (approximately 50m) was seined October 4 and October 5 to take advantage of the lower water level from the day before. Heavy weed growth made it difficult for the seine to reach the bottom of the canal. A gate located on the new flume allows upstream water pass through the flume during dewatering of the canal. Operation of this gate needs to be timed so fish are not trapped between the two structures (headgate & measuring flume) during dewatering. However, water levels on the downstream side of the flume need to be sufficient to prevent fish from being stranded. A few large white fish and numerous northern pike were stranded overnight (Oct 4-5) as fish passed through the flume gate to lower water levels on the downstream side of the flume.

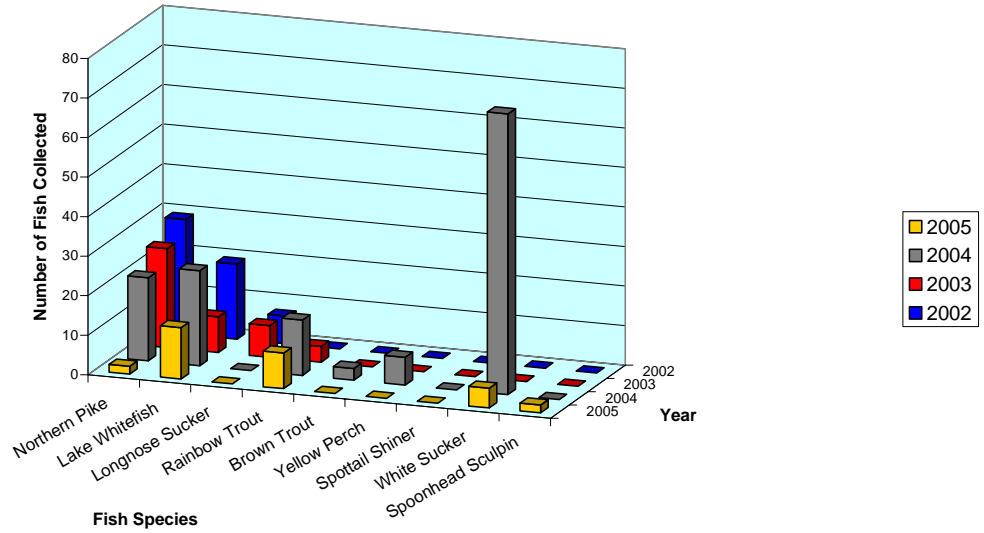
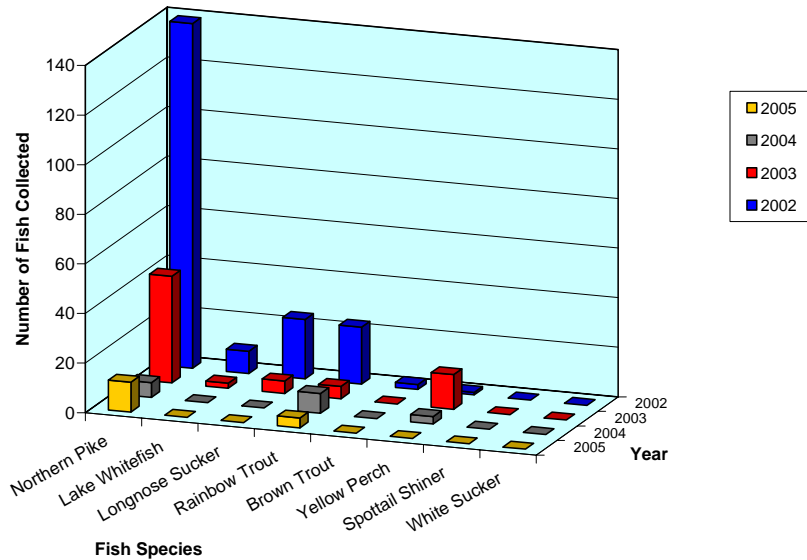
Site 1 Comparison of Species Collected 2002-2005

Site 8 Comparison of Species Collected 2002-2005

Figure 6: Comparison of numbers and fish species collected in 2002 - 2005 inclusive for Sites 1 (top) and 8 (bottom).

Assuming that all of the fish collected in this survey would die throughout the winter months if left in the canal, it is likely that the species and proportions of fish collected in this survey represent the species and proportions of fish removed from the system yearly (i.e. mostly White Sucker, Northern Pike, Lake Whitefish and to a much lesser extent Rainbow Trout, Brown Trout Yellow Perch, Spoonhead Sculpin and Burbot). Four years of data collection is beginning to reveal that distribution of the fish is highly variable site to site and from year to year while species collected remains reasonably consistent. Expanding the program to include additional sampling sites further downstream in the canal system would test the assumption that fish distribution and species composition is similar throughout the system. Overall numbers of fish collected in 2005 were greater than from 2004 for all species at Site 1, except for the absence of Longnose Sucker and Spottail Shiners. Spoonhead sculpins were added to the species found at Site 1 which had an overall decrease in numbers of all fish species captured.
