Fish Survey in Recently Dewatered Western Irrigation District Irrigation Canals

Western Irrigation District
Strathmore, Alberta
T6E 2R3

Aquality Environmental Consulting Ltd.
9822 88 Avenue
Edmonton, Alberta
T6E 2R3

October 2002

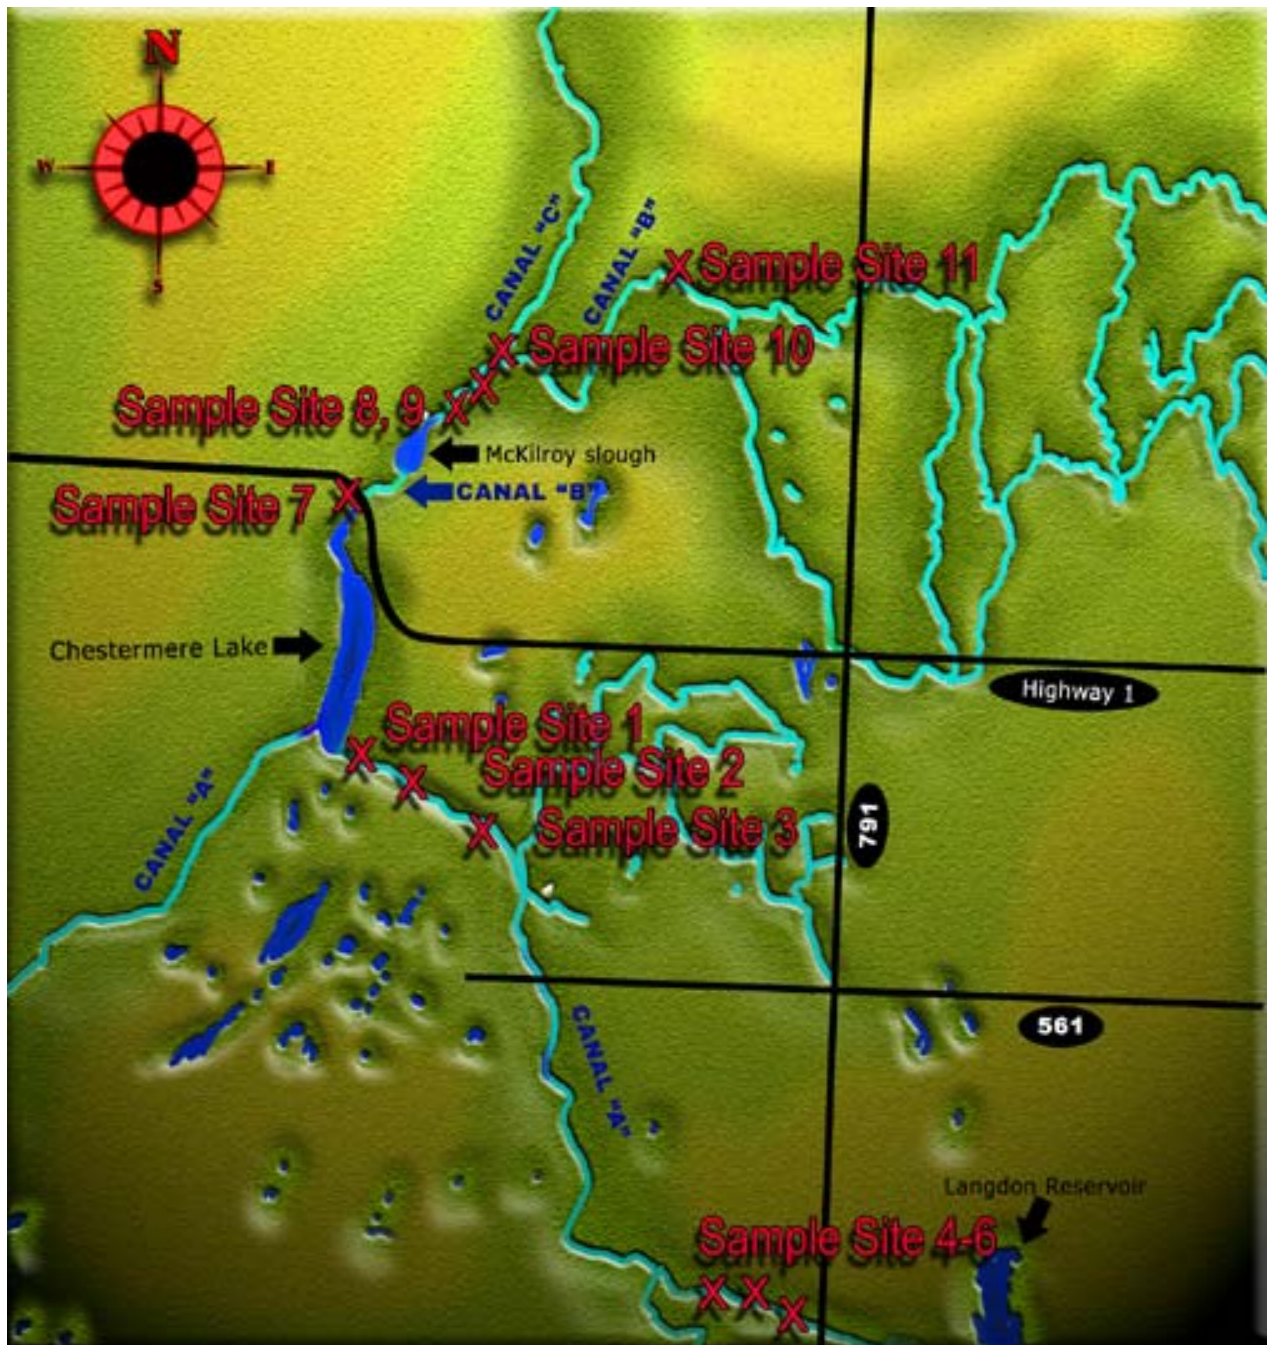
Figure 1: Sites sampled by AQUALITY on October 8 and 9, 2002 along dewatered WID canal headwater sites.

Headwater canals within the Western Irrigation District were sampled by Aquality Environmental Consulting Ltd. on October 8 and 9, 2002 following the fall canal dewatering. Sites immediately downstream of Chestermere Lake were selected along Canals A, B and C (Figure 1). Eleven sites were identified by WID operations staff, which had deep enough water to potentially hold fish. These sites were typically deep pools, found immediately downstream of large drop-structures where a plunge pool was an integral part of energy dissipation.

The October 8 and 9 2002 WID canal sampling locations appear in Figure 1. Sites 1-6 on Canal A were visited by Jay White, Nolan Yaskiw and Darcy Tetrault on October 8, while sites 7-11 on Canal B and C were visited by Jay White, Nolan Yaskiw and Wes Sproule on October 9.
